Chapter 5. Refuge Facilities and Public Use Programs

5.1 Refuge Infrastructure and Operational Facilities

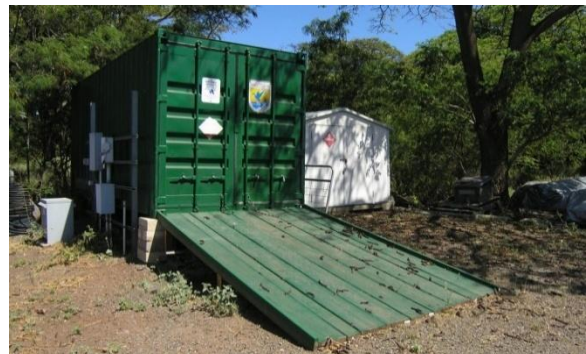
Kakahai‘a storage units USFWS

The primary maintenance facilities include a metal container and shed to secure equipment and supplies. This minimal storage is sufficient given the amount of non-wetland area available and the unstaffed Refuge status.

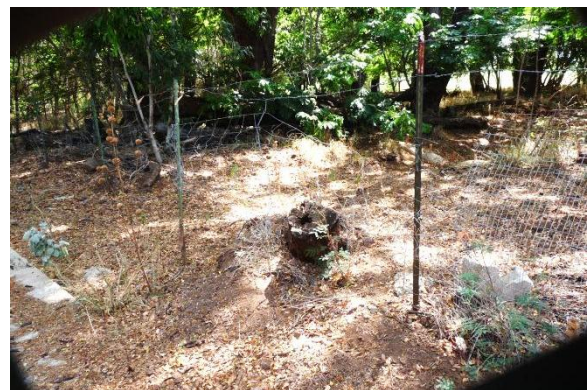
Damaged fence along the northern boundary USFWS

There are two fences at Kakahai‘a NWR. One fence encompasses both Old and New Ponds, coastal forest habitat, open grassland areas, and the maintenance area. Although in fairly good condition along the highway, along the eastern boundary it is susceptible to sediment buildup from runoff and erosion. It is also heavily impacted by axis deer and it requires periodic repairs. The portion of this fence that is parallel with the entrance road was replaced in 2010-11 when the Refuge entrance road

was paved. The north side of the fence, along its entire length, is in need of replacement.
